IV. THE INCIDENT

A. The AFRAMAX’s Governor System was Unseaworthy and Its Malfunction was a Proximate Cause of the Allision

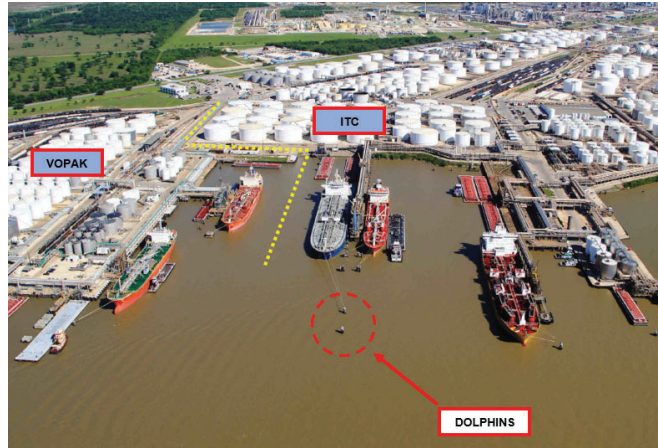
4. The exemplary photo below separately depicts the Dolphins looking S/SE from HFO:
